**Fortress Fire**<sup>®</sup>  
Wildfire Risk Solutions

# Wildfire Disclosure Report

For Wildfire Risk, Remediations and Insurability Assessment

**1234 Bradley Road**  
Santa Clarita, CA 91351

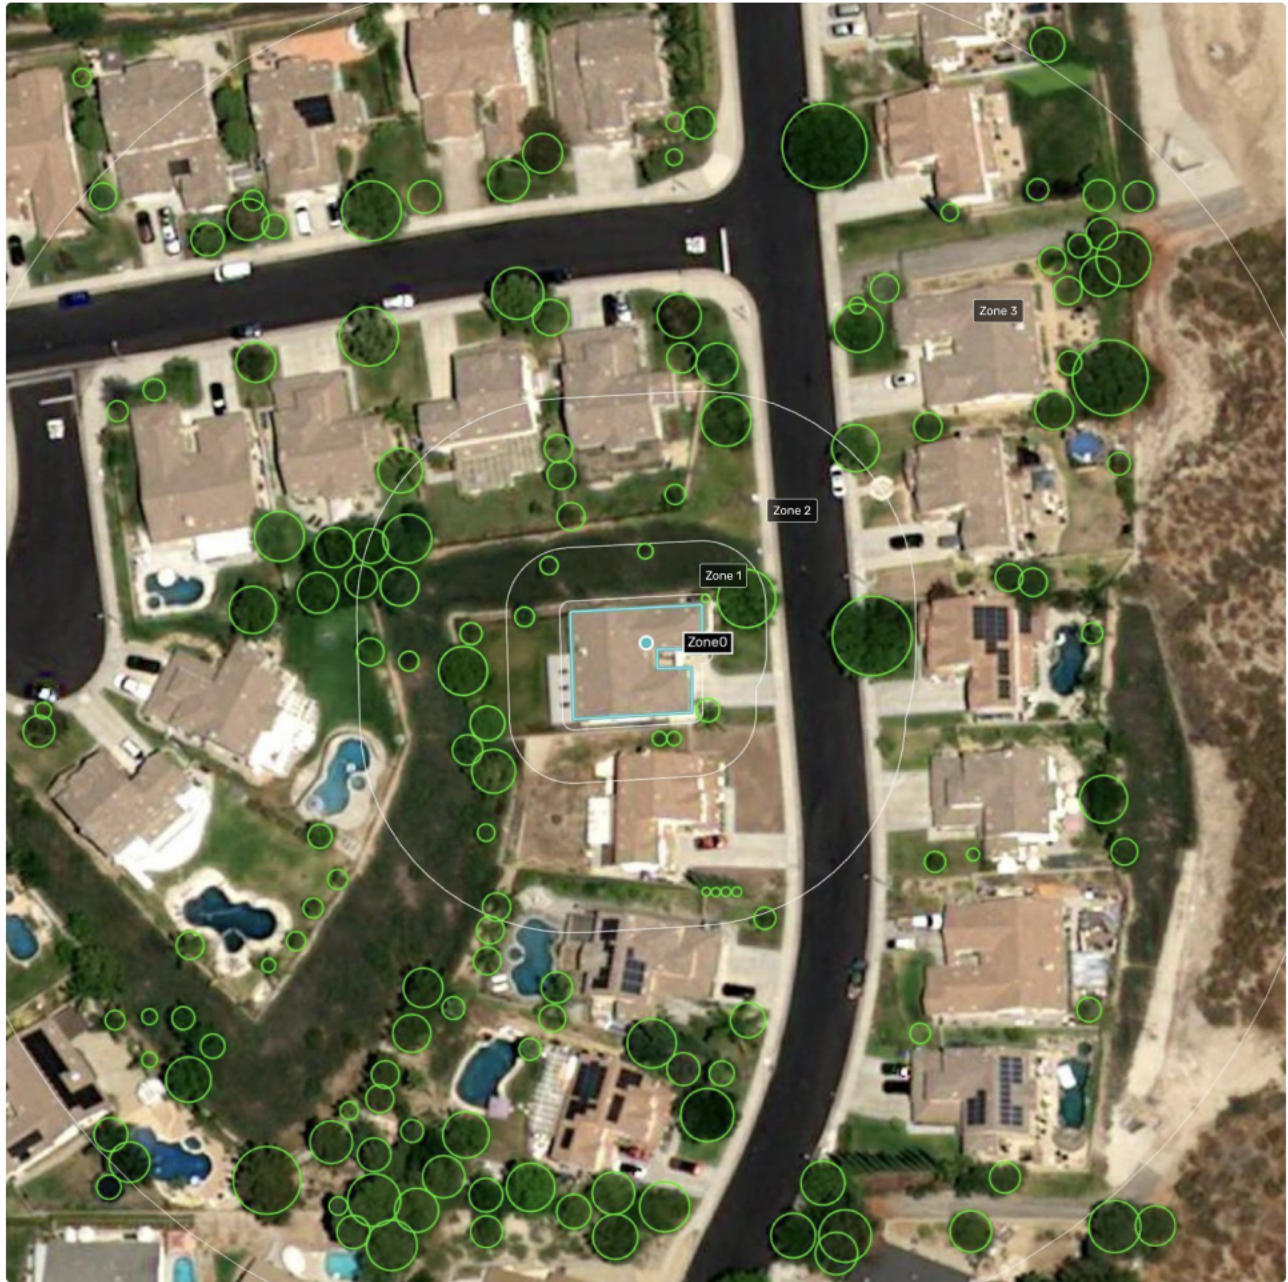
Aerial Image provided by Airbus on 7/24/2023

Address	1234 Bradley Road Santa Clarita, CA, 91351	Year Built	1992
Structure Analyzed	Primary Structure	Stories/Levels	1
County	Los Angeles	Roof Perimeter / Roof Area	263 ft / 2,814 sqft
APN	160-281-5392	Lot Size	0.36 acres
Lat/Long	471.435098 / -261.463981	Roof Material	Tile   Client
Property Type	Residential	Exterior Wall Material	Stucco   Client

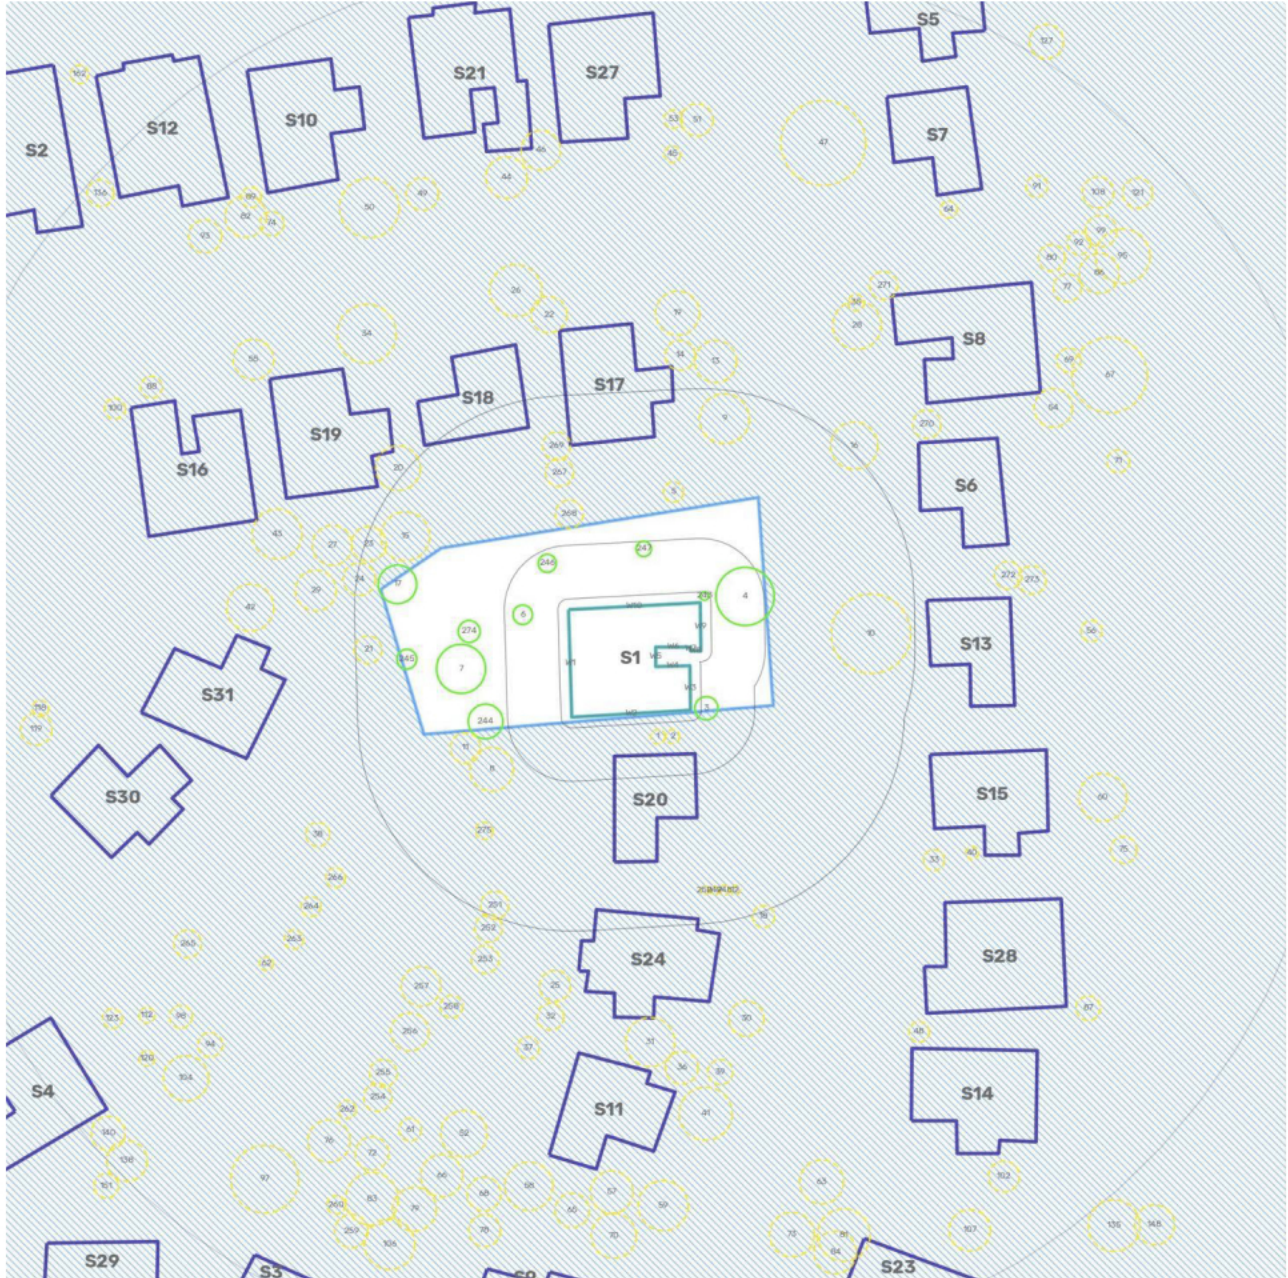
The property schematic represents the inventory of fuel sources, structures, and property footprint that become the inputs to PIM. The schematic is combined with building materials data to perform our analysis. Parcel data is sourced from public records and plotted while the model identifies, numbers, and labels the fuel sources along with the sides of the structure. Generally speaking, the closer trees or other fuel sources are to a structure, the higher the risk of their contribution to ignition risk. Tree canopy analysis can isolate the trees that factor most significantly to wildfire risk. The table at the bottom of the page indicates the sum of specific fuel sources.

Trees in Zones 0-2

**35**

Trees on Parcel

**11**

Structures in Zones 0-2

**5v**

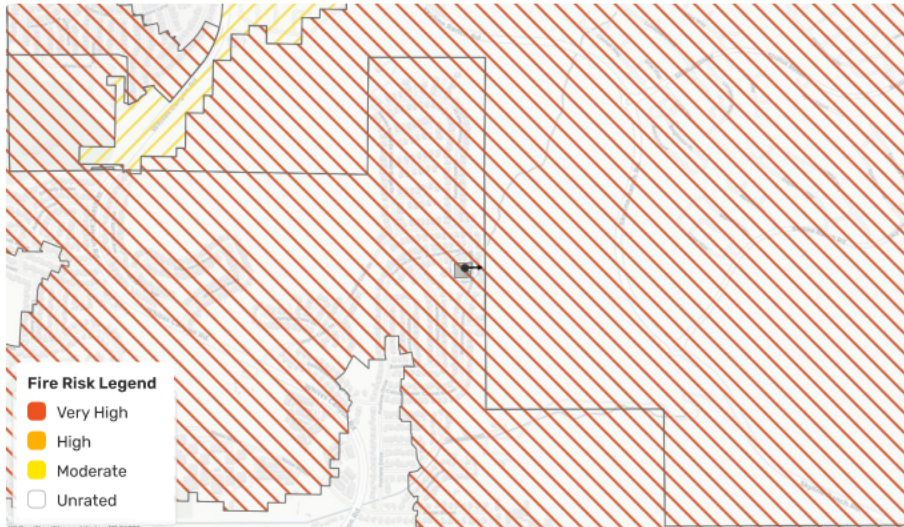
### CalFire Rating

**Very High** (LRA)

### Distance to Closest Neighboring Zone

**1.04 miles**

The Fire Hazard Severity Zone (FHSZ) maps are developed by CalFire using a science-based and field-tested model. Many factors are considered such as fire history, existing and potential fuel (vegetation), predicted flame length, blowing embers, terrain, and fire weather for the area.

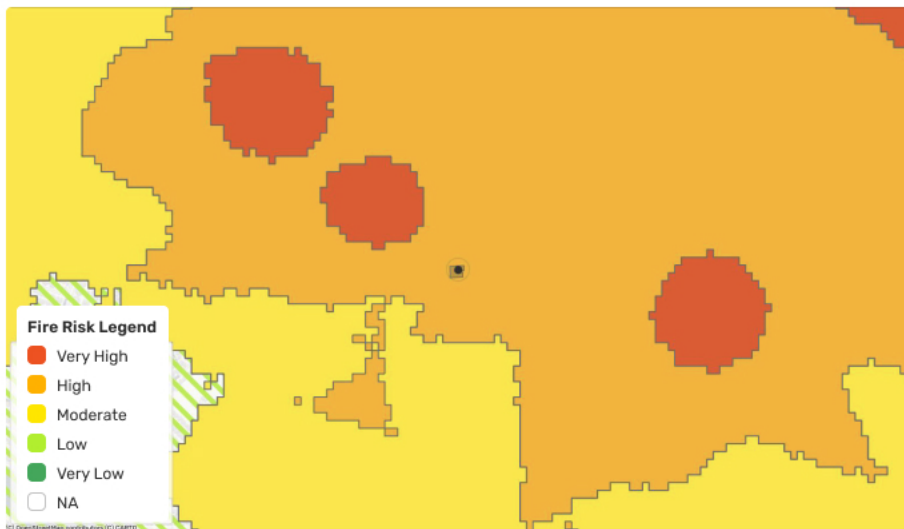
### USDA Rating

**High**

The Wildfire Hazard Potential (WHP) map is produced by the USDA Forest Service's Fire Modeling Institute to help inform evaluation of wildfire hazard or prioritization of fuels management needs across very large landscapes. The specific objective with the WHP map is to depict the relative potential for wildfire that would be difficult for suppression resources to contain.

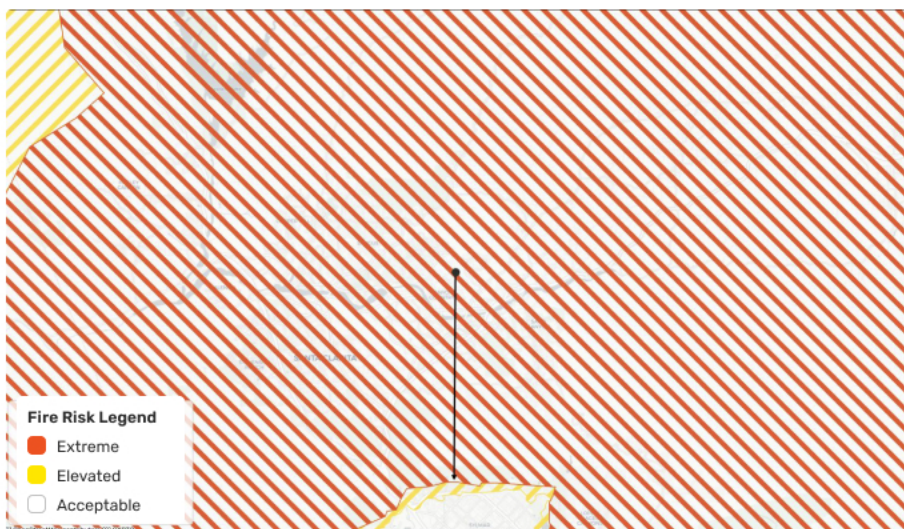
### CPUC Rating

**Extreme**

### Distance to Closest Neighboring Zone

**7.29 miles**

The California Public Utility Commission (CPUC) adopted a fire threat map to identify areas of heightened fire risk for use by utilities for risk reduction activities. The map was developed in collaboration with CalFire, the Office of Emergency Services, and utilities.

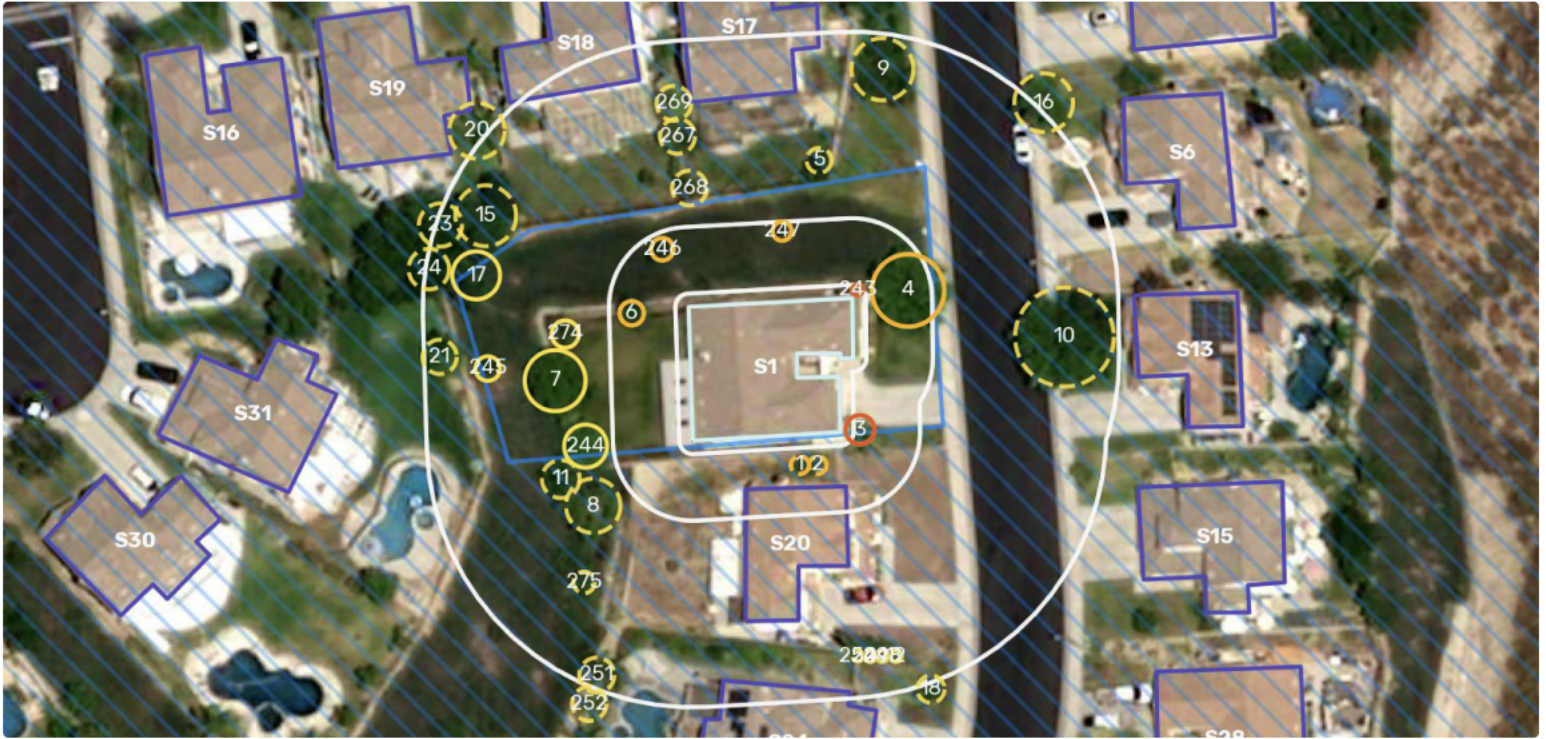
Trees are counted in the zone closest to the structure in which the tree canopy extends. Trees marked with a solid **Red** line are identified as Zone 0 trees, trees marked with a solid **Orange** line are identified as Zone 1 trees, trees marked with a solid **Yellow** line are identified as Zone 2 trees. Trees marked with a dotted line are identified as off parcel. Off parcel trees are not subject to AB 38 compliance but may be relevant in the Vulnerability analysis.

Roof must be Class A – non-combustible material  
 Roofing composition must be confirmed via onsite inspection  
 Bird stops and/or roof flashing must be sealed

Tile | Client – **Compliant**

**Compliance Pending Inspection**

**2 Total Zone 0 Tree(s)**

**4 Total Zone 1 Tree(s)**

**5 Total Zone 2 Tree(s)**

Remove all branches overhanging structures

Remove all trees, trim back branches and remove any vegetative debris

Trim trees to separate canopies by 10 feet and limb up 6 feet from the ground

Remove fuels in accordance with the Zone 2 Fuel Separation or Continuous Tree Canopy guidelines

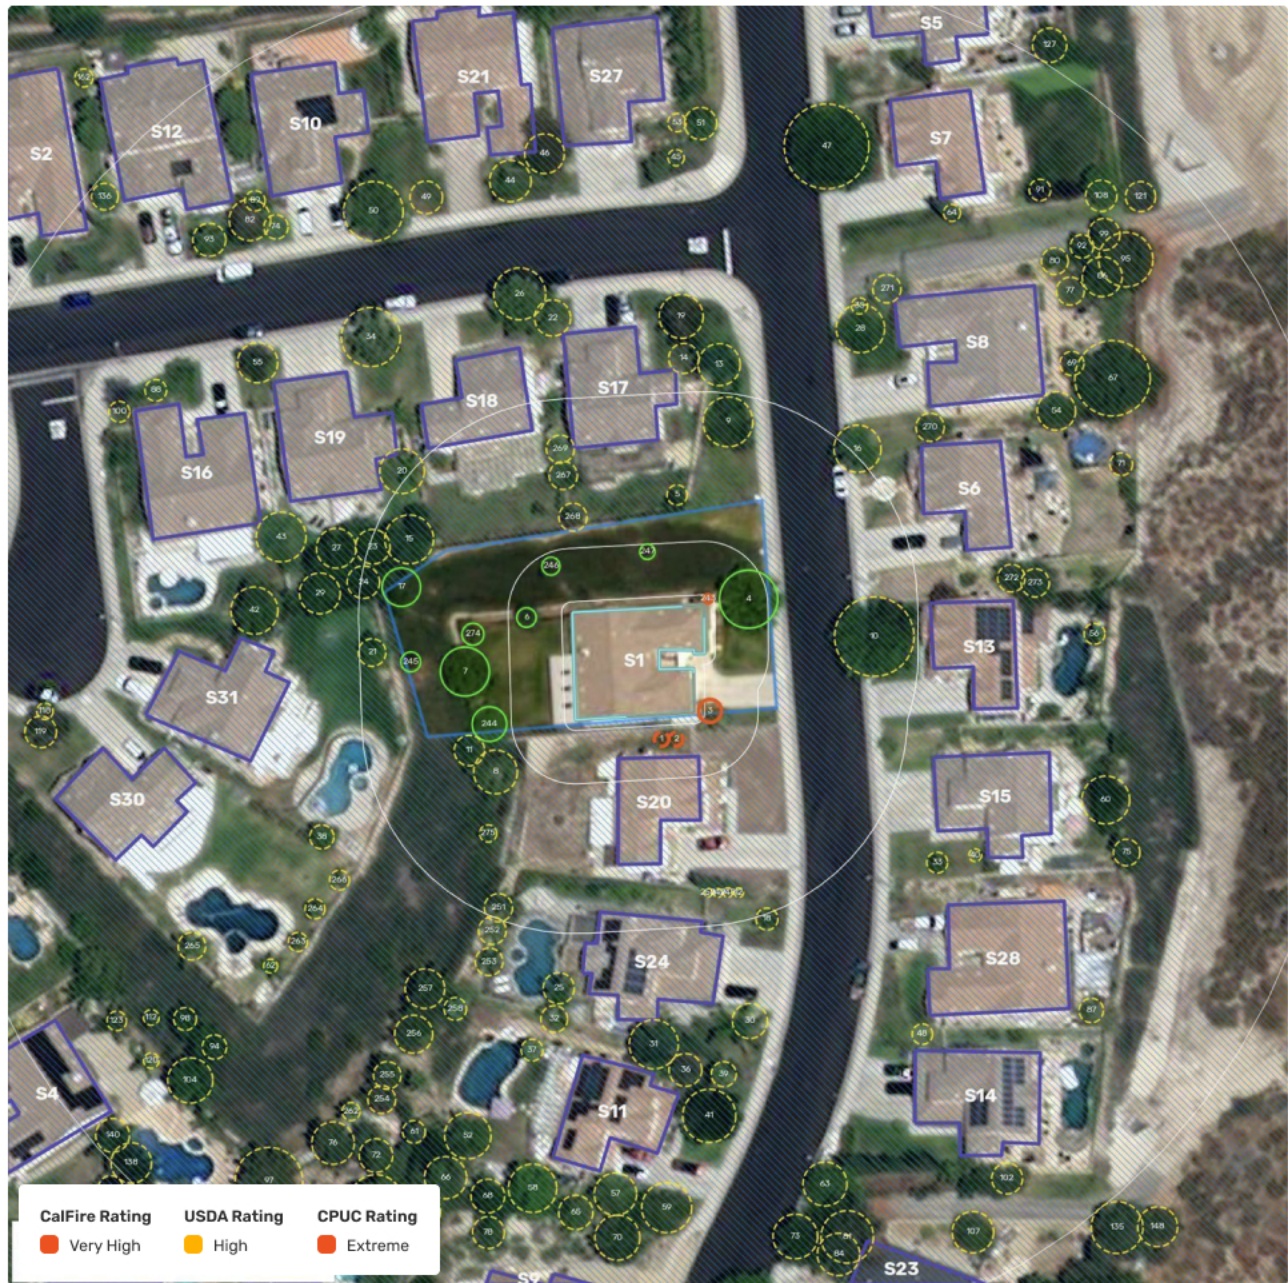
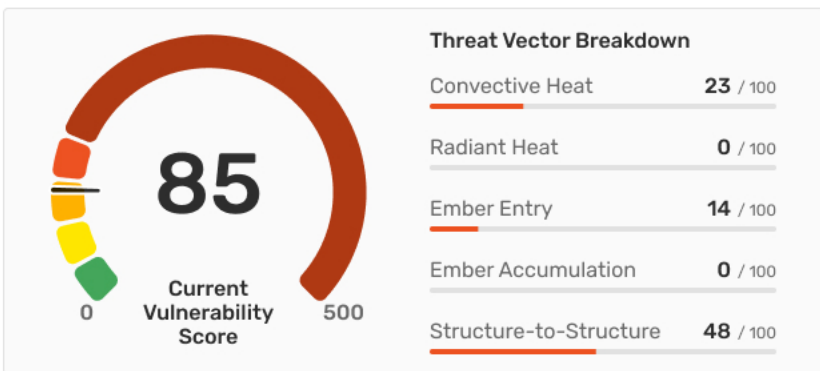
- Currently 172.7 linear feet of perimeter ignitions represent a combination of convective and radiant threats.
- The treatment of 7 trees will lower structural ignition risk.
- Trimming of limbs and other detailed mitigation services are recommended to reduce risk.
- Secondary structure(s) identified in the photo as S2 should be included in mitigation planning.
- Recommend active asset monitoring and protection plans including long-term fire retardant application to maintain and protect properties once mitigations are implemented.

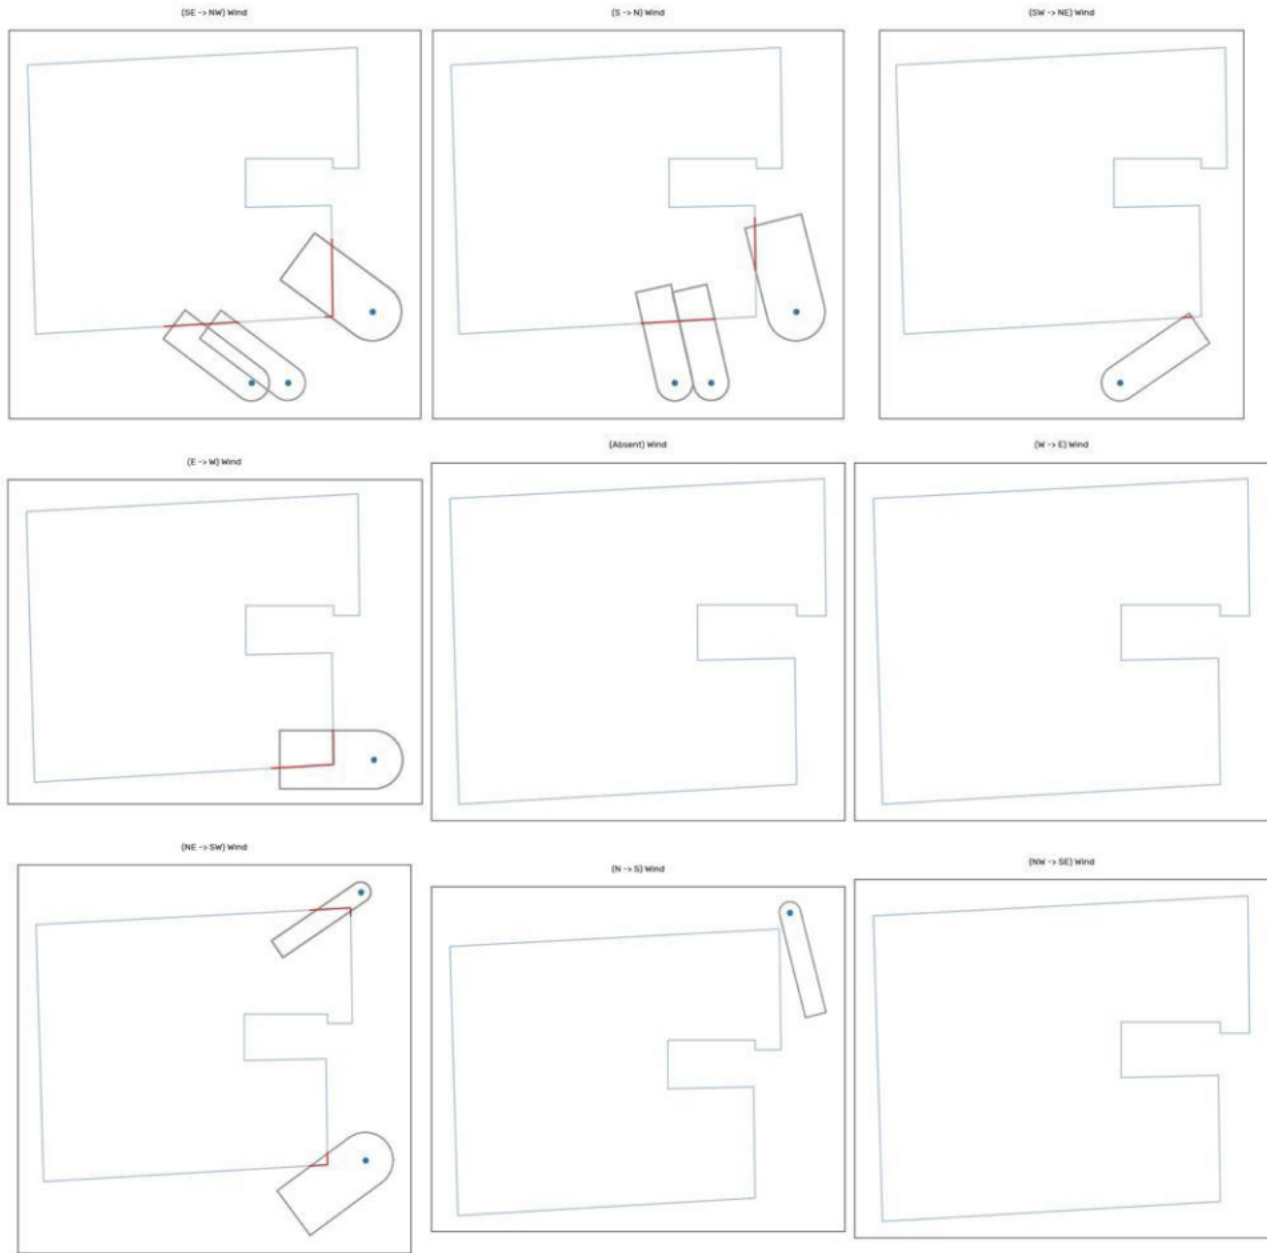
The boxes below indicate flame touch for each of the 8 standard wind directions and in the middle a no-wind scenario is indicated. The curved side of the trees indicates the side of the tree from where the wind is coming from and the flat end indicates the flame length extension. Red indicates flame touch on the structure.

Sum of Perimeter Ignition

**66 ft.**

(Total linear feet of structure walls that are vulnerable to Convective ignition in the above model)

Unique Contributing Trees

**4**

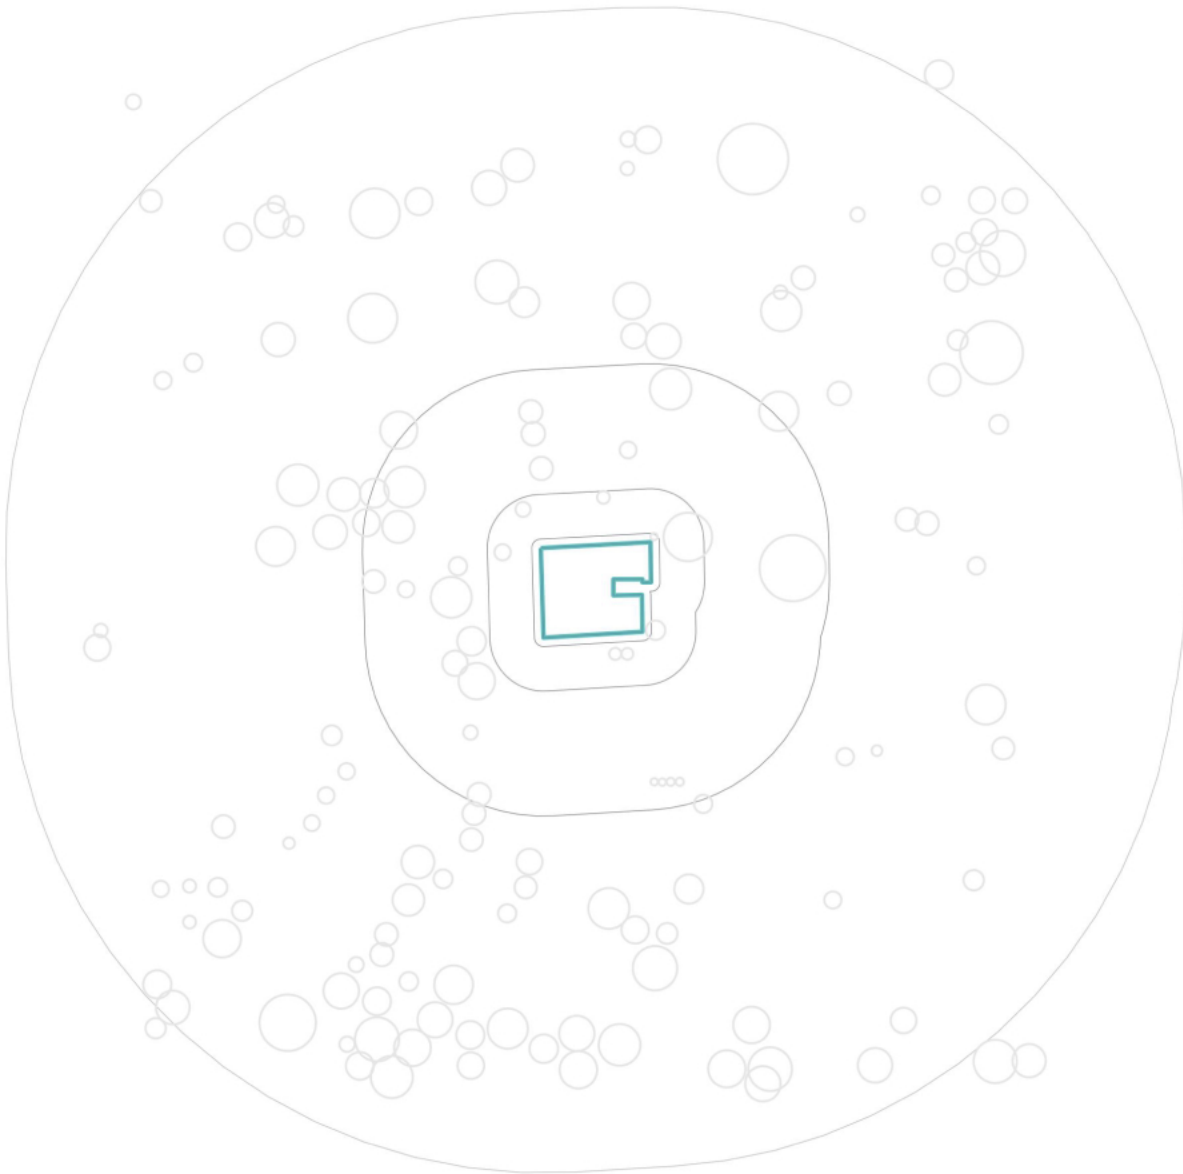
Radiant heat is heat projected from outside a flame (such as heat generated by patio heater). While all potential fuel sources are analyzed, PIM identifies the key contributors to radiant heat. This diagram identifies the top contributing vegetative fuel sources to highlight the highest risk fuel sources.

Primary Material Considered  
**Stucco**  
Client

Window Type  
**Double Pane**  
Default

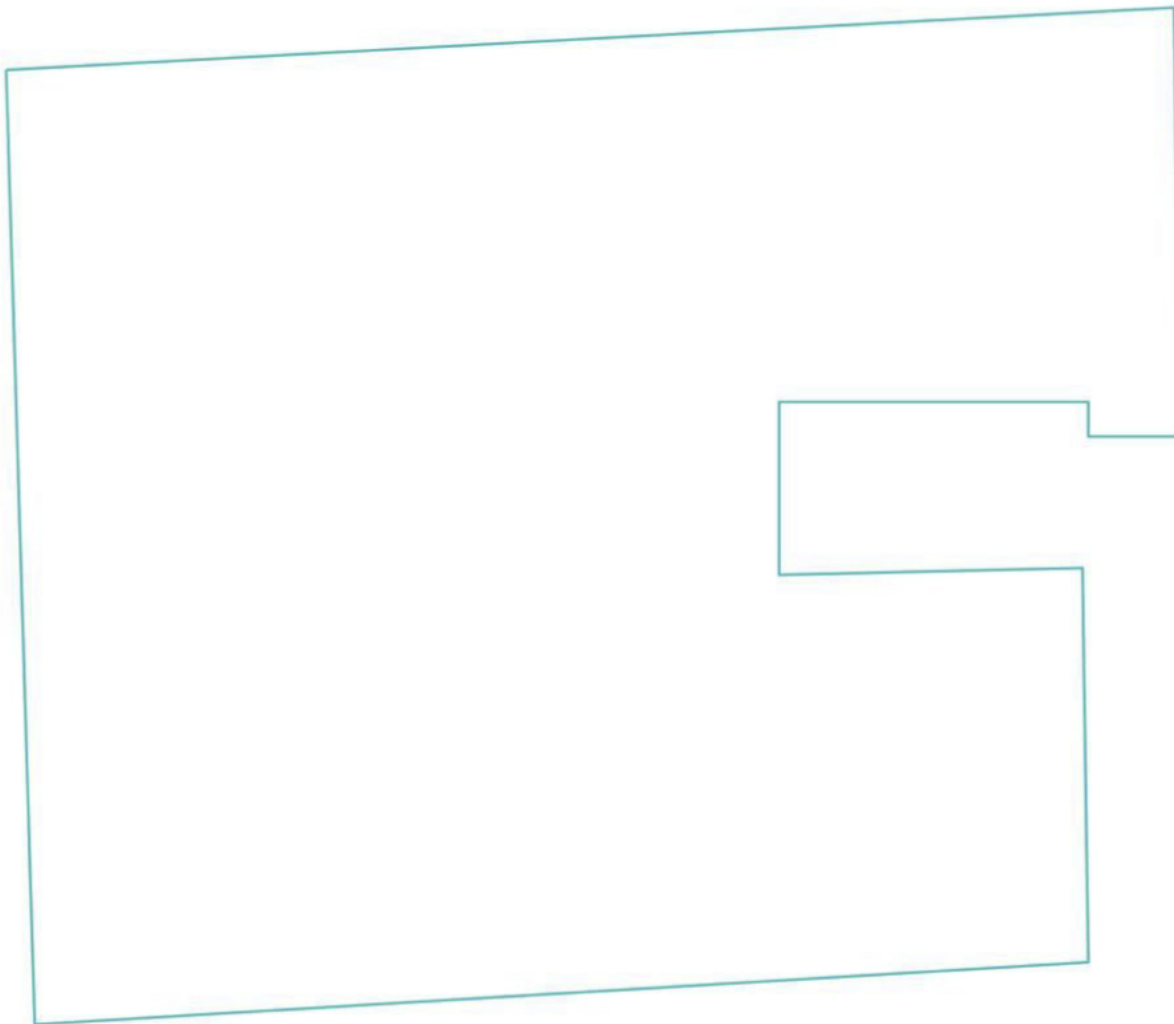
Radiant heat analysis illustrates the areas of a structural wall that will ignite from radiant heat. PIM analyzes structure walls in two-foot-wide segments. The wall segments that will ignite in a peak fire scenario are highlighted in red in the illustration below. The circles represent the trees contributing the most heat to ignited wall segments and the yellow lines connect the trees to the ignited wall segments that they contribute to.

Primary Material Considered

**Stucco**  
Client

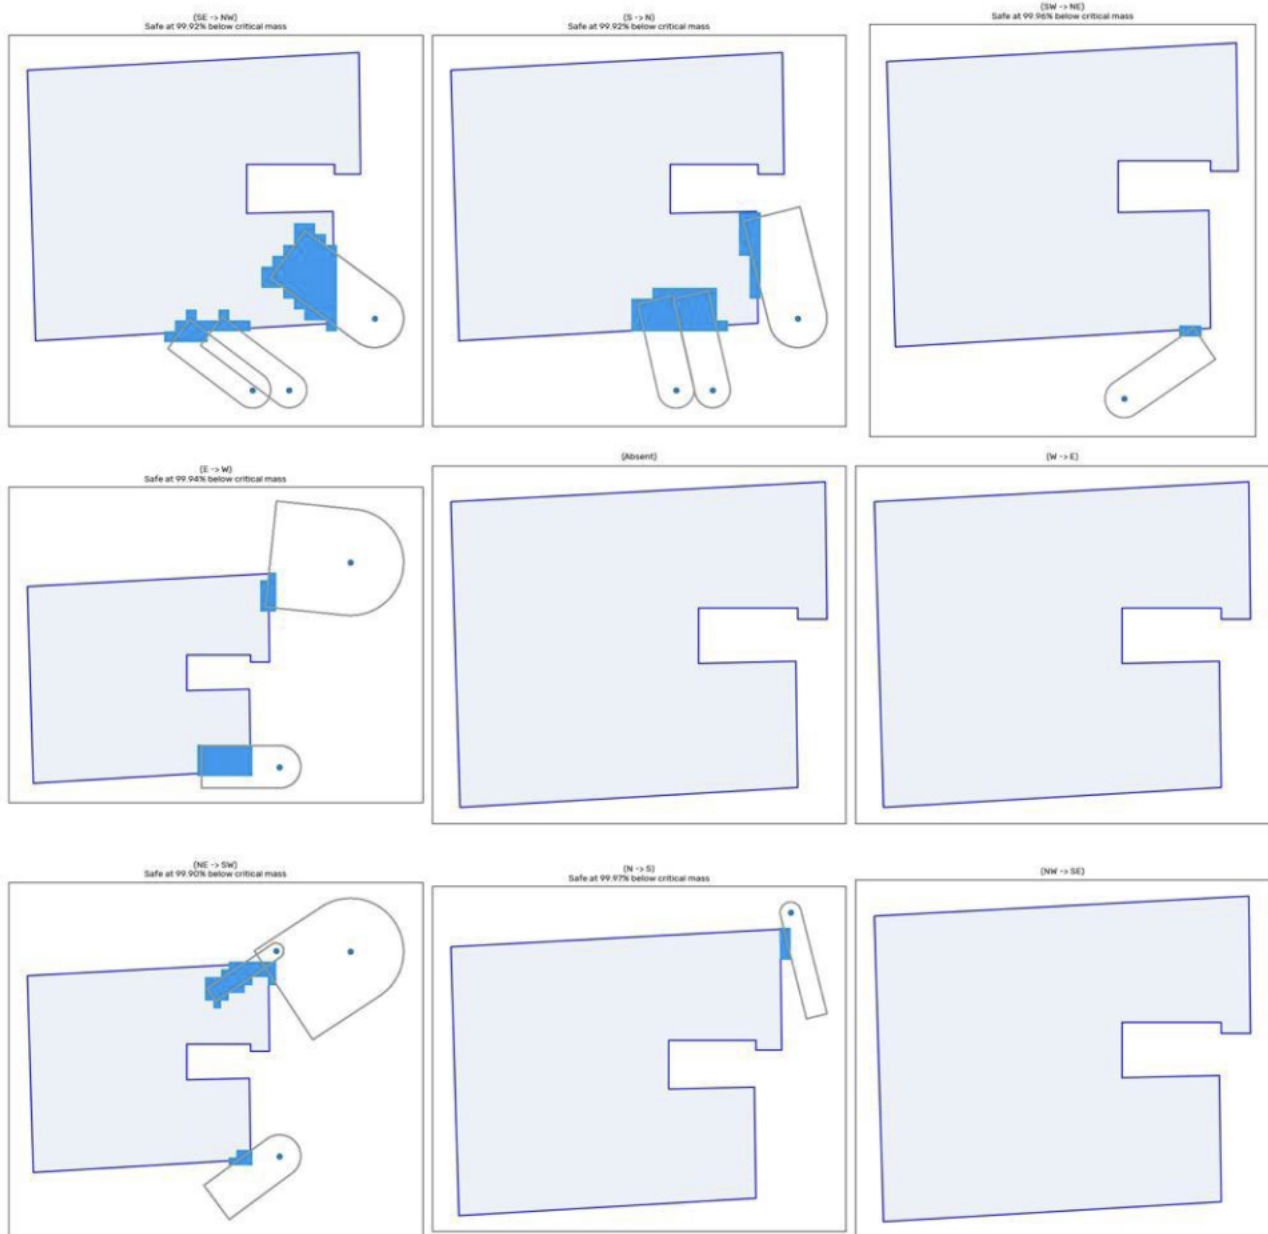
Ember accumulation is the estimate of embers ejected from surrounding fuel sources that accumulate on flat surfaces of the structure, primarily the roof. PIM calculates ember projection from burning fuels based on the size and proximity of fuel sources. Then the model measures ember movement from all wind scenarios and estimates the ember accumulations on the property's roof. Debris accumulated on roofs or gutters can be ignited by embers and an inspection is necessary to confirm whether the roof is clean. In most cases, clean asphalt shingle roofs, or other non-combustible roof materials, will not burn through as a result of ember accumulation.

■ Surplus Energy / Structure Ignition      ■ No Surplus Energy / No Structure Ignition

Primary Material Considered  
**Tile Roof**  
Client

Roof Condition Assumed  
**Clean**

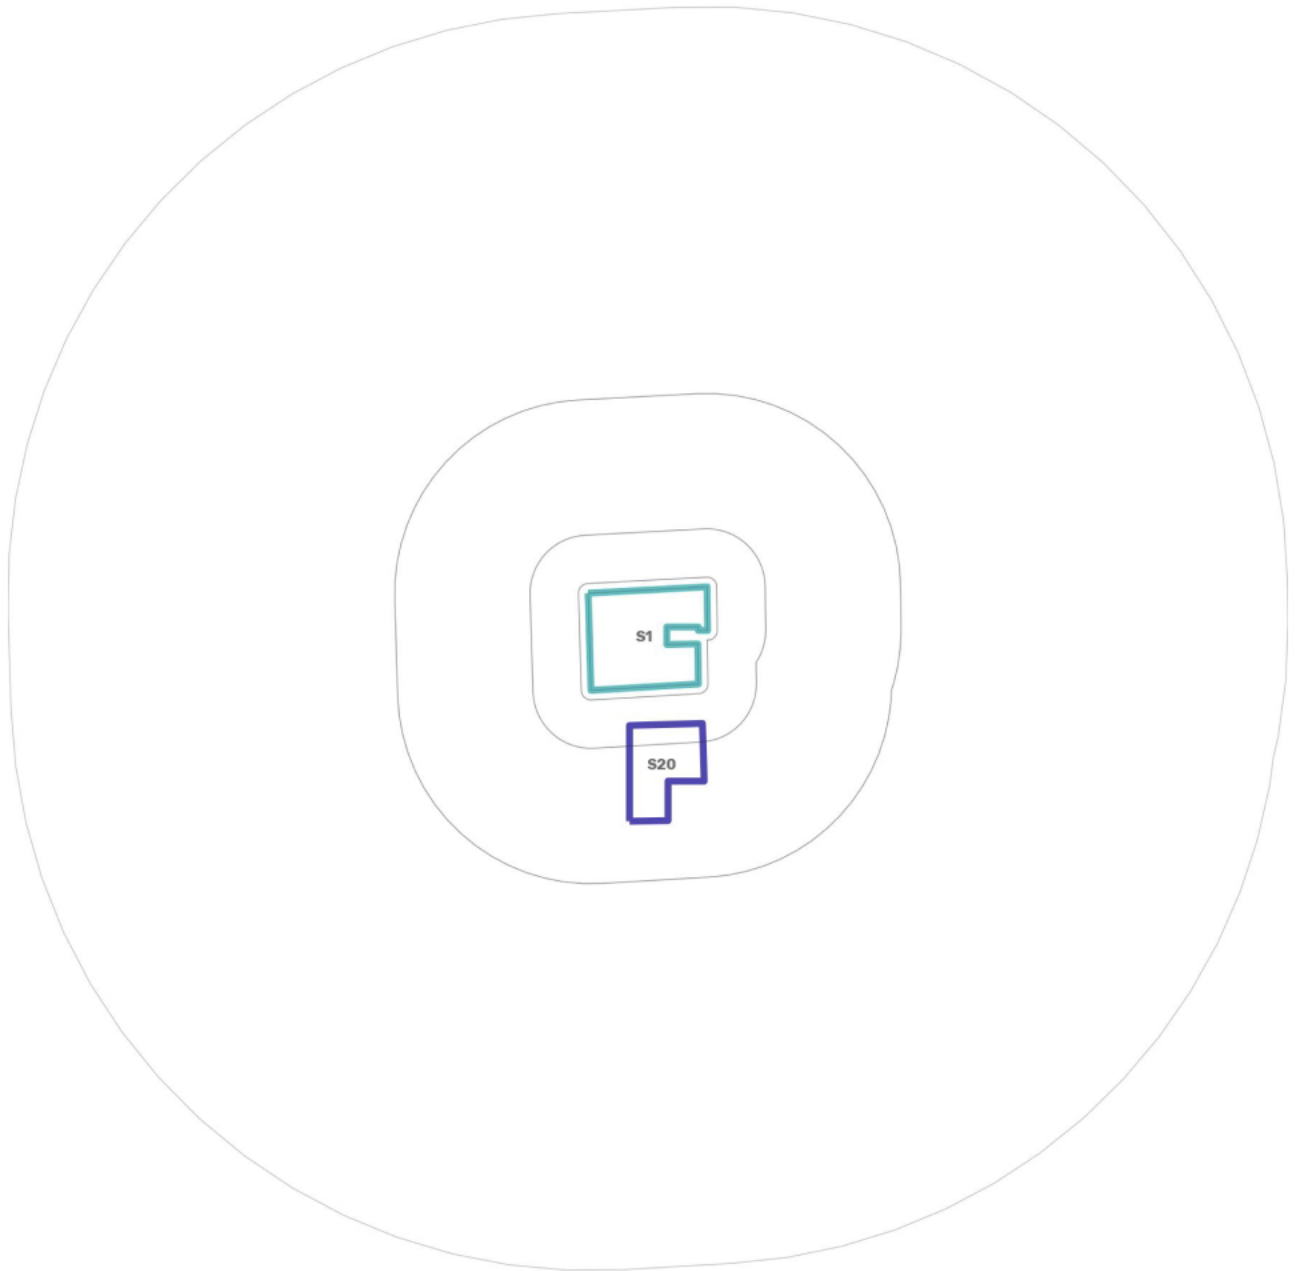
All structures within 30 feet of the primary structure (S1) represent fuel source risks that are close enough to cause ignition and are shown below.

Structures within 30 feet of Main Structure

1

To protect the primary structure, the vulnerabilities of any secondary structures must also be mitigated. The Mitigation Plan will list these structures as necessary to protect the primary structure. An inspection can identify the specific measures to address the risk presented by secondary structures. Insurance underwriters may require a full PIM assessment for secondary structures.

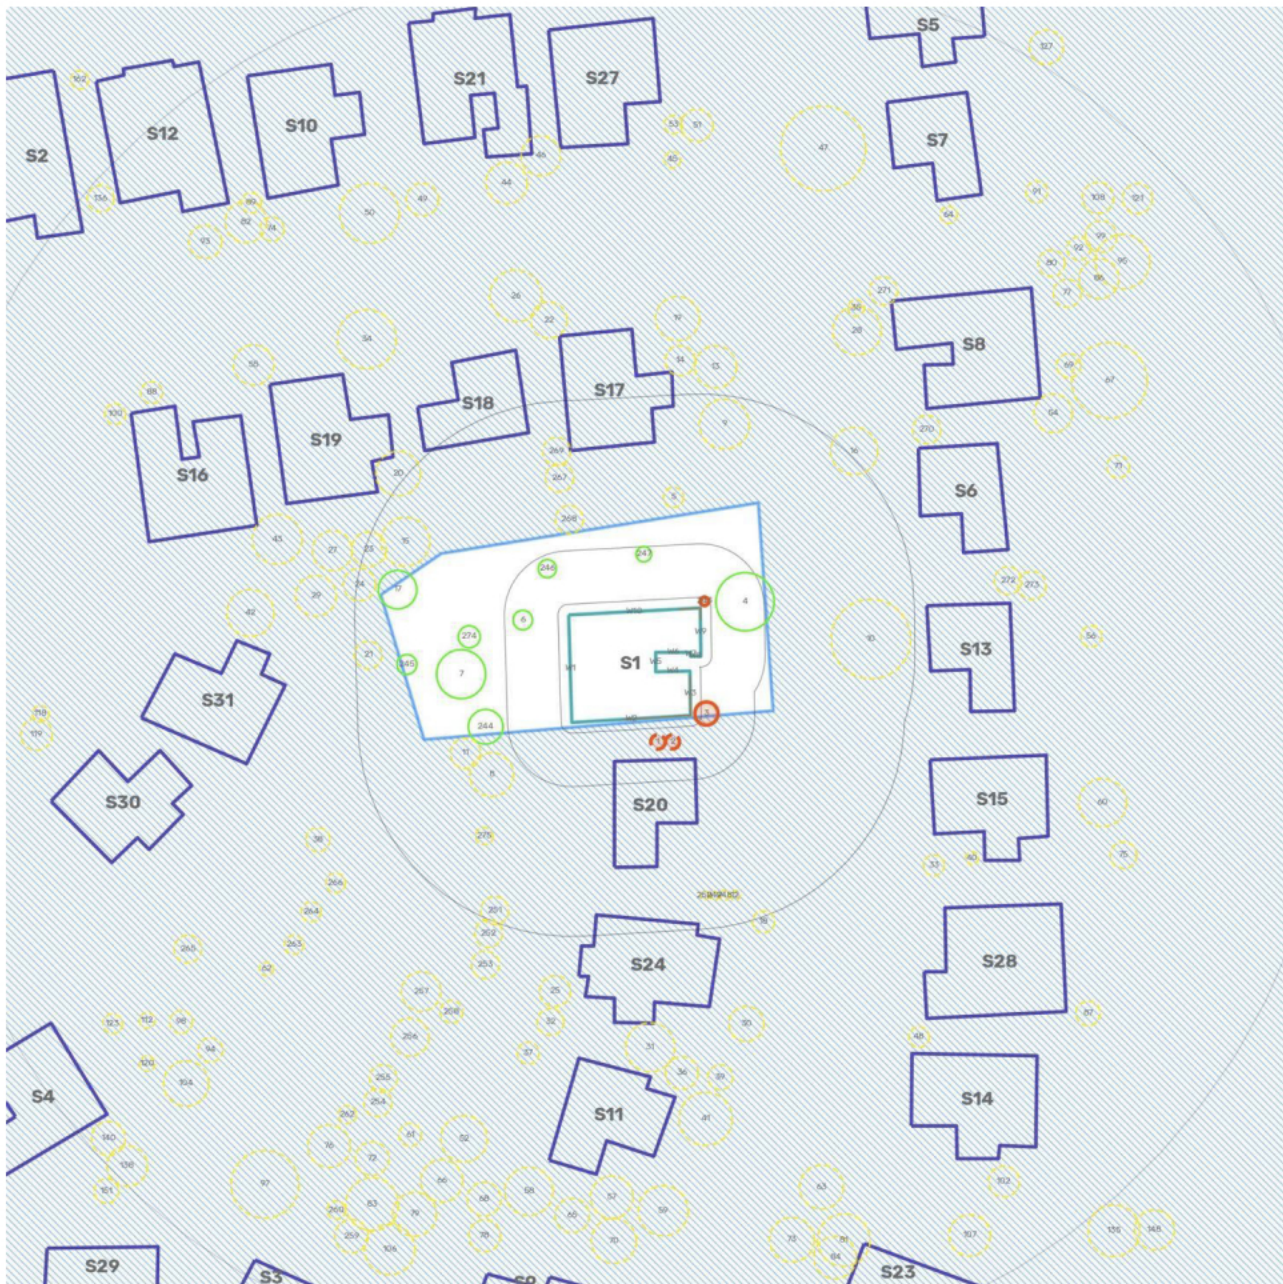
A Mitigated Vulnerability Score is generated after analysis of the five threat vectors, and the Mitigation Vulnerability Score is compared to the Vulnerability Score provided earlier in this report.

Convective Solution Trees	4 Total Tree(s) – Tree IDs 1, 2, 3, 243	\$3,200 - \$11,600
Radiant Solution Trees	0 Total Tree(s)	\$0
Structure to Structure	0 Total	TBD pending inspection
Vents	Structures built before 2010 may most likely require vent replacements	TBD pending inspection
Vegetation Management	Additional vegetative mitigations may be required after inspection	TBD pending inspection
<b>TOTAL</b>		<b>\$3,200 - \$11,600</b>
