Fortress Fire[®]
Wildfire Risk Solutions

Wildfire Disclosure Report

For Wildfire Risk, Remediations and Insurability Assessment

1482 Maple Valley Lane
Westlake Village, CA 91358

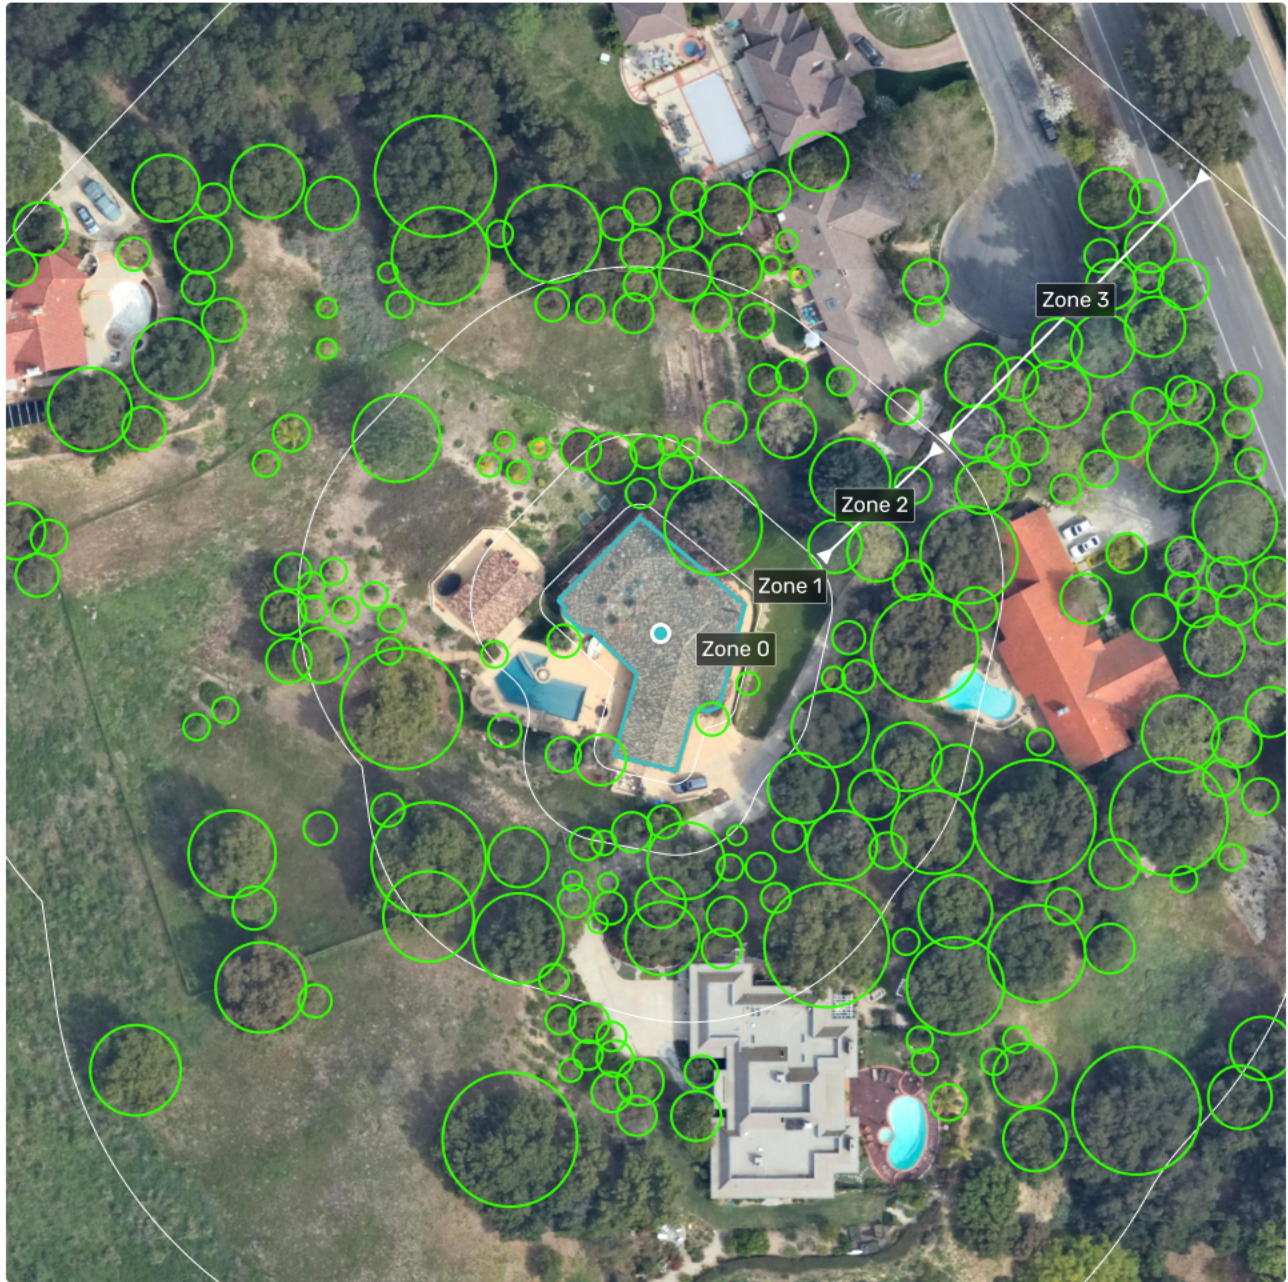
Subject Property Details

Aerial Image provided by Vexcel on 9/2/2023

Address	1482 Maple Valley Lane Westlake Village, CA 91358	Year Built	1981
Structure Analyzed	Primary Structure	Stories/Levels	2
County	Ventura	Roof Perimeter / Roof Area	416 ft / 4,256 sqft
APN	123-740-5729	Lot Size	1.23 acres
Lat/Long	14.861741 / -207.141823	Roof Material	Tile Client
Property Type	Residential	Exterior Wall Material	Stucco Client

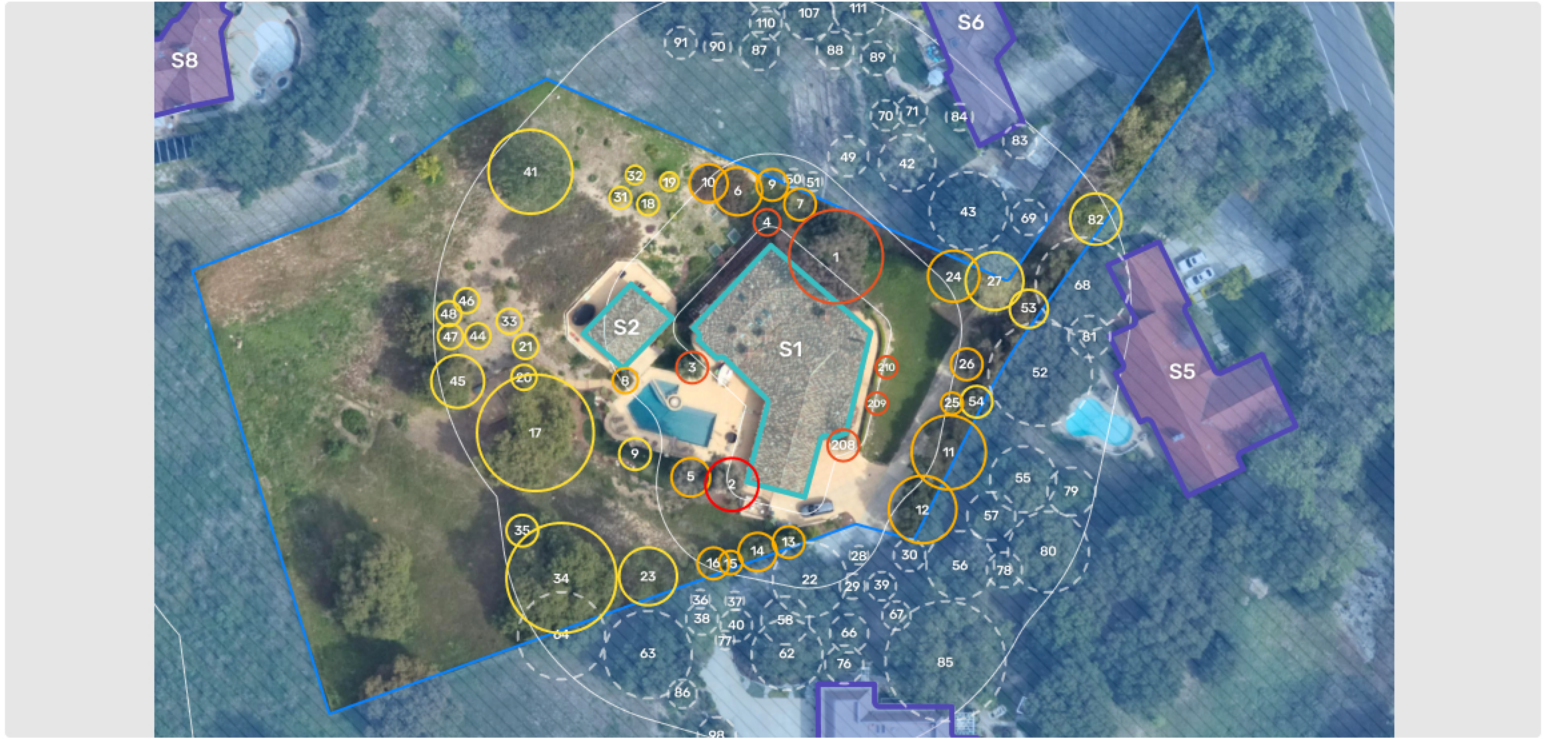
AB 38 & IBHS Wildfire Protected Home Compliance Summary

Trees are counted in the zone closest to the structure in which the tree canopy extends. Trees marked with a solid **Red** line are identified as Zone 0 trees, trees marked with a solid **Orange** line are identified as Zone 1 trees, trees marked with a solid **Yellow** line are identified as Zone 2 trees. Trees marked with a dotted line are identified as off parcel. Off parcel trees are not subject to AB 38 compliance but may be relevant in the Vulnerability analysis.

Roof must be Class A – non-combustible material
 Roofing composition must be confirmed via onsite inspection
 Bird stops and/or roof flashing must be sealed

Tile | Client – **Compliant**

Remove all branches overhanging structures

3 Non-Compliant Tree(s)

7 Total Zone 0 Tree(s)

15 Total Zone 1 Tree(s)

22 Total Zone 2 Tree(s)

1 Secondary Structure(s) on Property

Remove all trees, trim back branches and remove any vegetative debris

Trim trees to separate canopies by 10 feet and limb up 6 feet from the ground

Remove fuels in accordance with the Zone 2 Fuel Separation or Continuous Tree Canopy guidelines

Outbuildings and propane tanks have no flammable vegetation for 10 feet around exterior

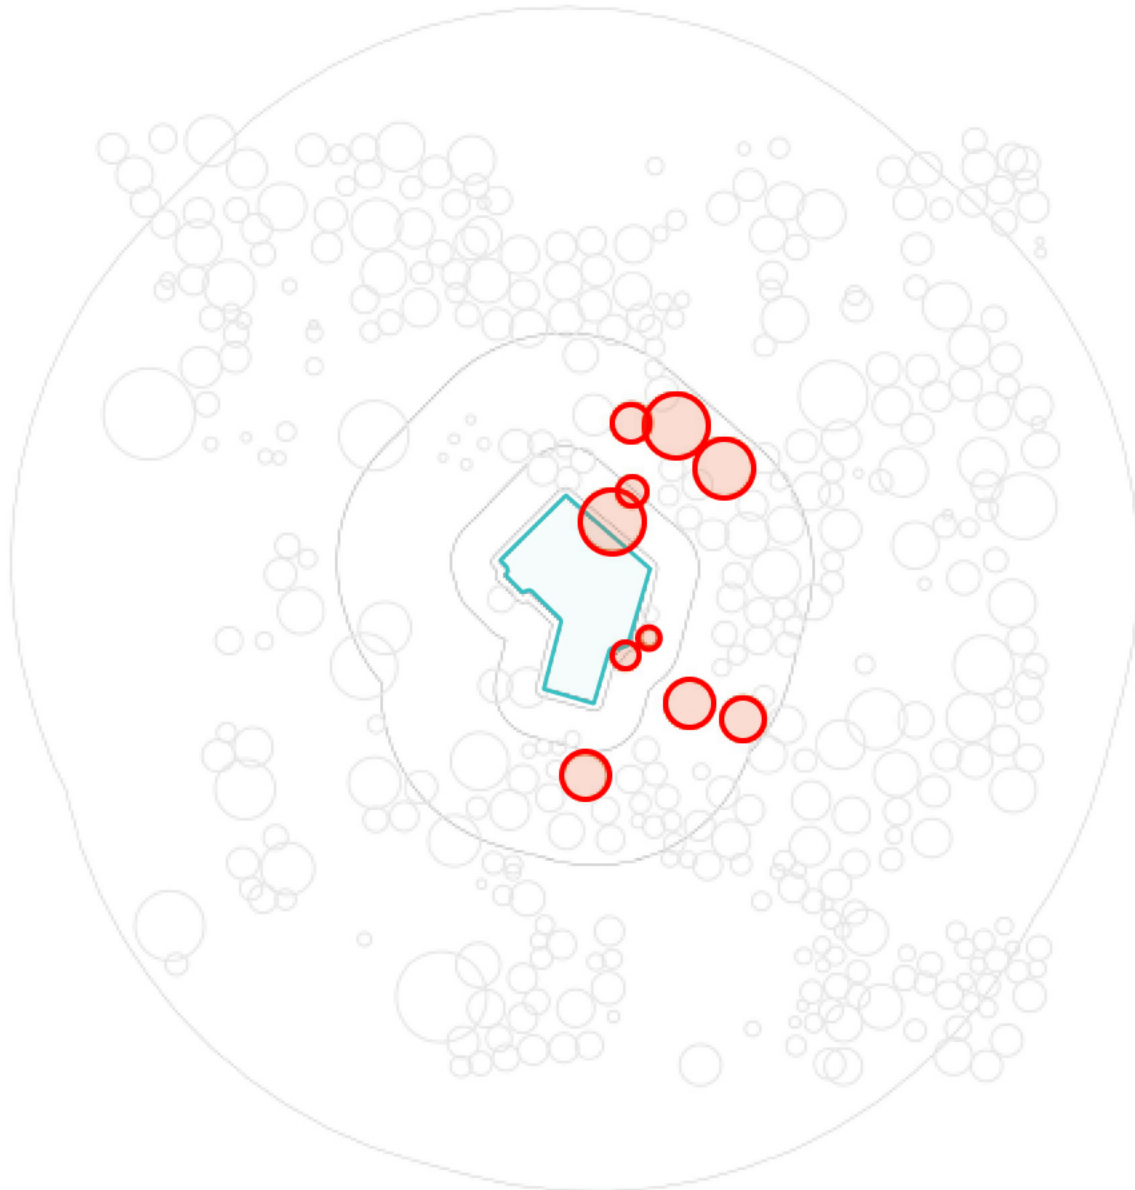
Radiant Heat Failure Analysis

Radiant heat is heat projected from outside a flame (such as heat generated by patio heater). While all potential fuel sources are analyzed, PIM identifies the key contributors to radiant heat. This diagram identifies the top contributing vegetative fuel sources to highlight the highest risk fuel sources.

Primary Material Considered
Stucco
Client

Window Type
Double Pane
Default

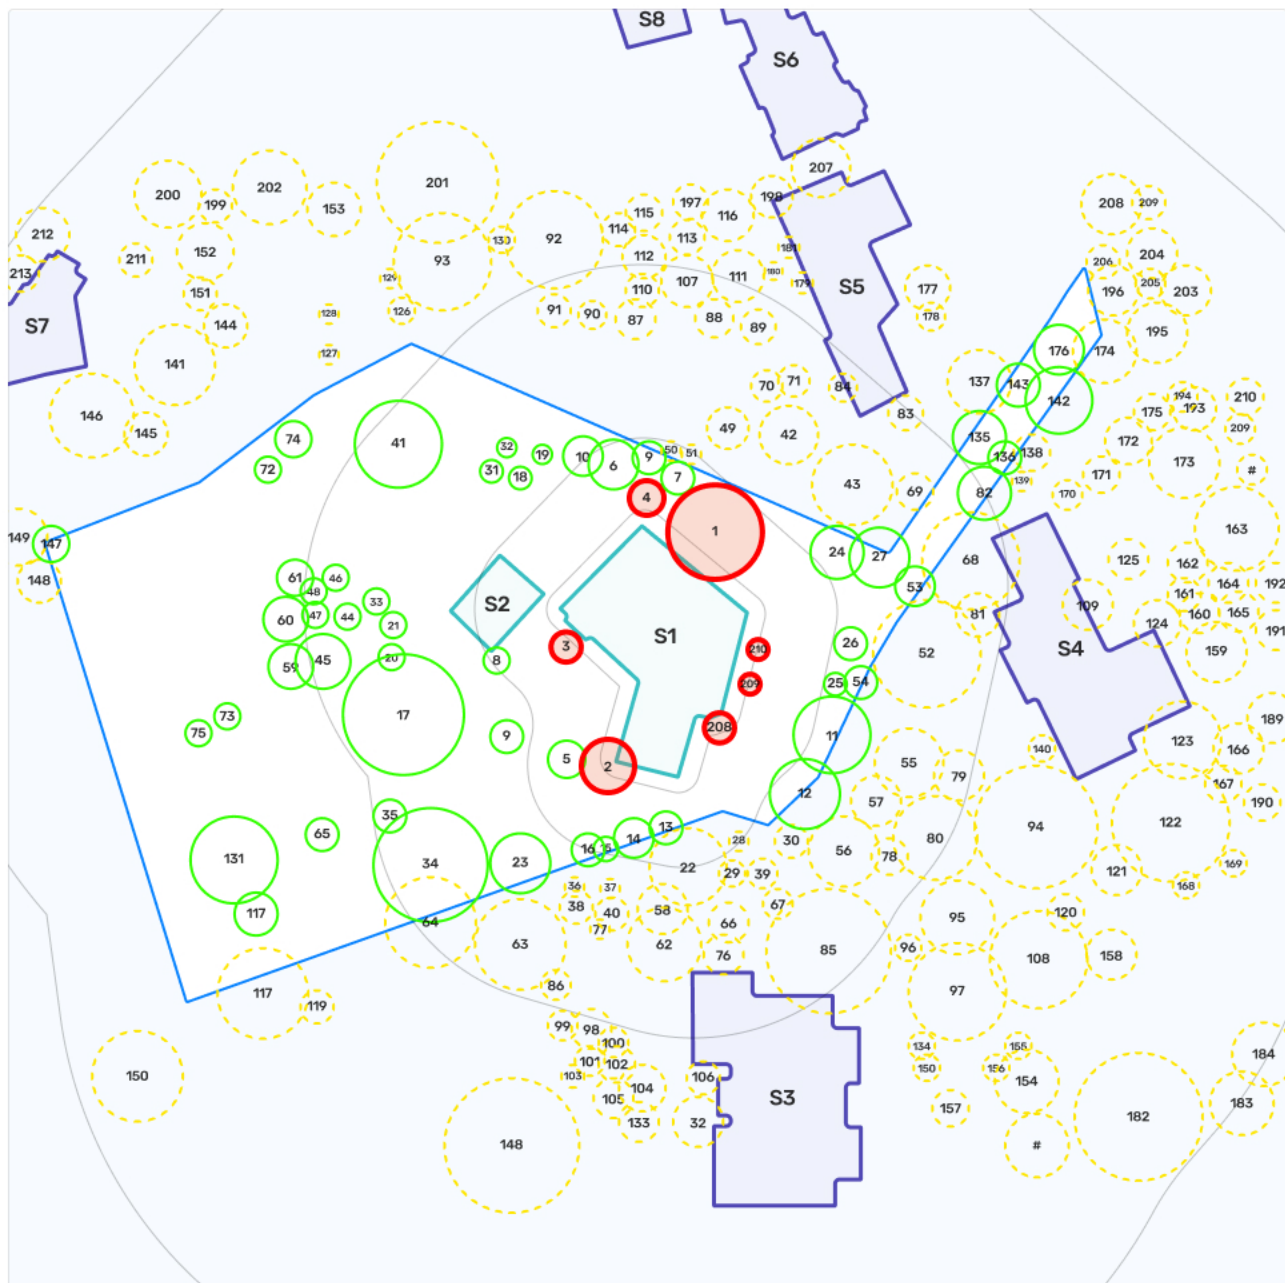
Vulnerability Mitigation Summary

A Mitigated Vulnerability Score is generated after analysis of the five threat vectors, and the Mitigation Vulnerability Score is compared to the Vulnerability Score provided earlier in this report.

Convective Solution Trees	7 Total Tree(s) - Tree IDs 1, 2, 3, 4, 208, 209, 210	\$2,800 - \$9,800
Radiant Solution Trees	0 Total Tree(s)	\$0
Structure to Structure	1 Total - Structure IDs S2	TBD pending inspection
Vents	Structures built before 2010 may most likely require vent replacements	TBD pending inspection
Vegetation Management	Additional vegetative mitigations may be required after inspection	TBD pending inspection
TOTAL		\$2,800 - \$9,800
